SSC-366

**THRESHOLD CORROSION  
FATIGUE OF WELDED  
SHIPBUILDING STEELS**

THRESHOLD CORROSION FATIGUE OF  
WELDED SHIPBUILDING STEELS

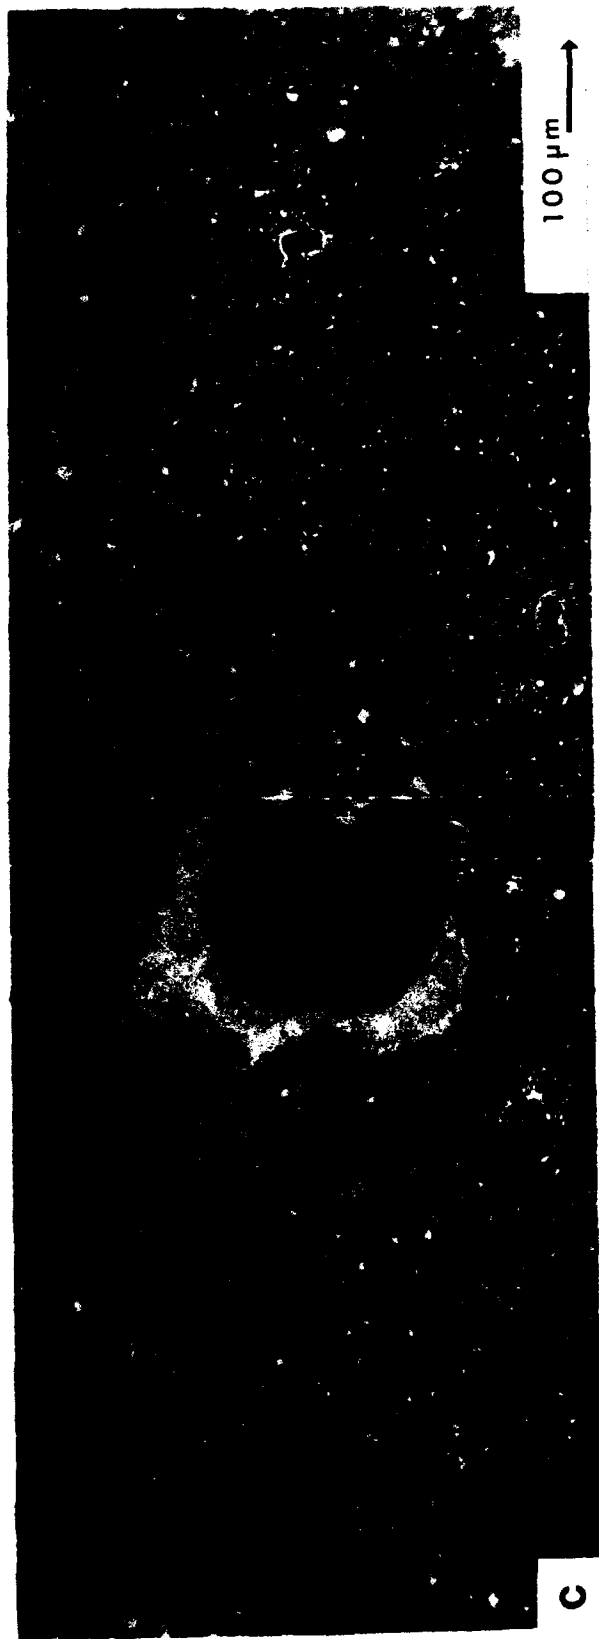
Figure 37. Higher magnification views of MIL S-24645 base metal tested in ASTM seawater at the free corrosion potential at 0.2 Hz under load increasing conditions (test #2).

Figure 37. Continued

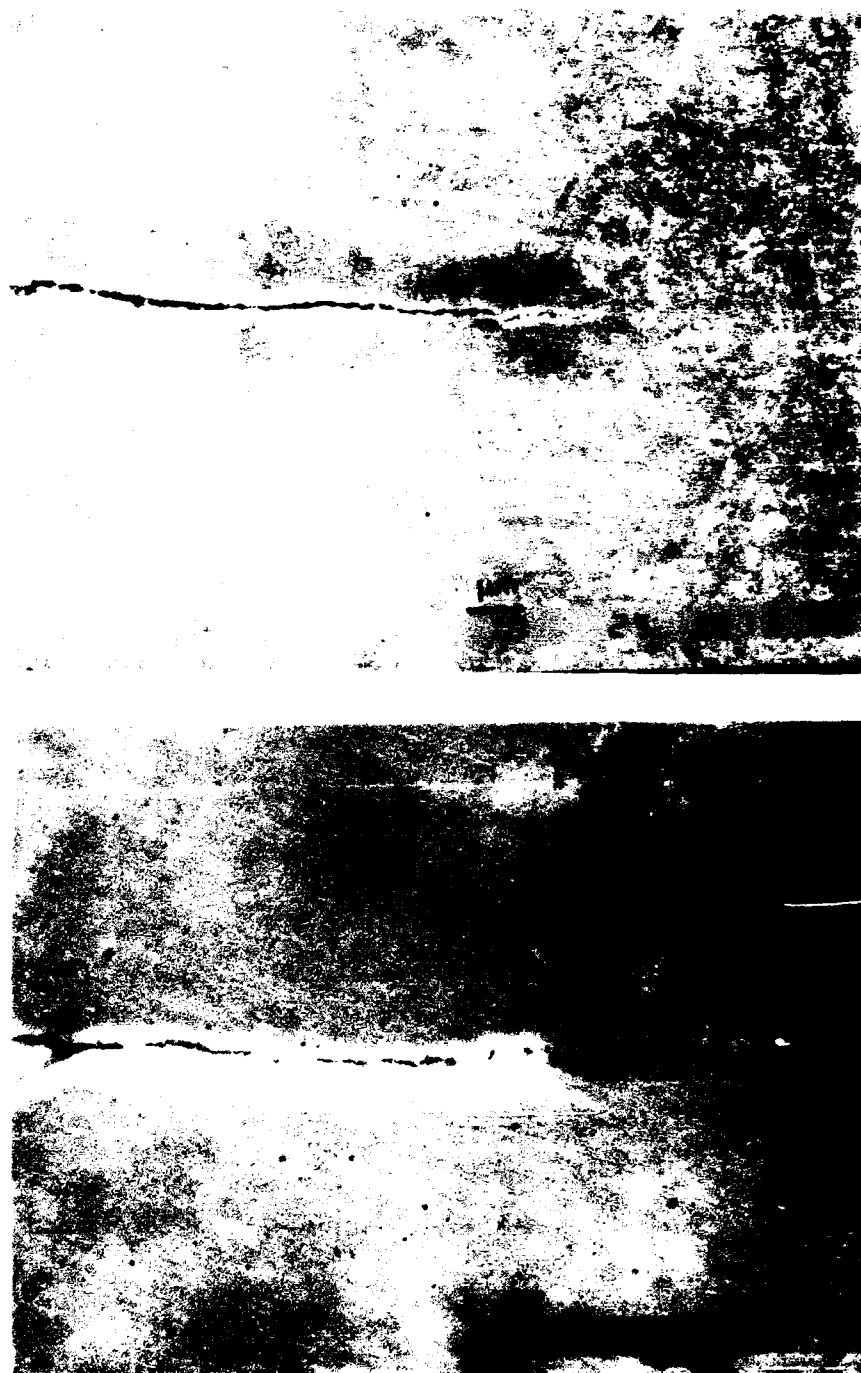
**Figure 53.** SEM micrographs of the fracture path (near crack tip) of MIL S-24645 steel in the weld tested at 10 Hz at -1.0V in seawater: (a) 750 X, 5% Nital; (b) 1500 X, unetched.
